OPERATING EXPERIENCE WEEKLY SUMMARY

Office of Nuclear and Facility Safety

October 1 - October 7, 1999

Summary 99-40

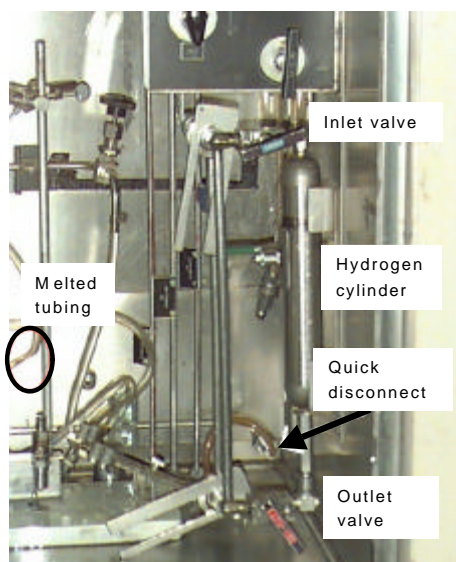
Figure 6-1. Laboratory Hood Set-up

The operator informed the Advanced Test Reactor shift manager of the fire and inspected the ventilation system ducting for evidence of fire. Although the operator determined that there was no ongoing fire in the ducting, he discovered smoke in a room downstream of the laboratory hood high-efficiency particulate air (HEPA) filters, indicating a failure of the filters. Figure 6-1 shows the laboratory hood set-up.

Investigators removed the HEPA filters and discovered that they were charred. They believe that fine, lint-like particulates inside the ductwork upstream of the HEPA filters were ignited by the hydrogen fire. OEAF engineers will follow the investigation and provide additional information, as it becomes available.

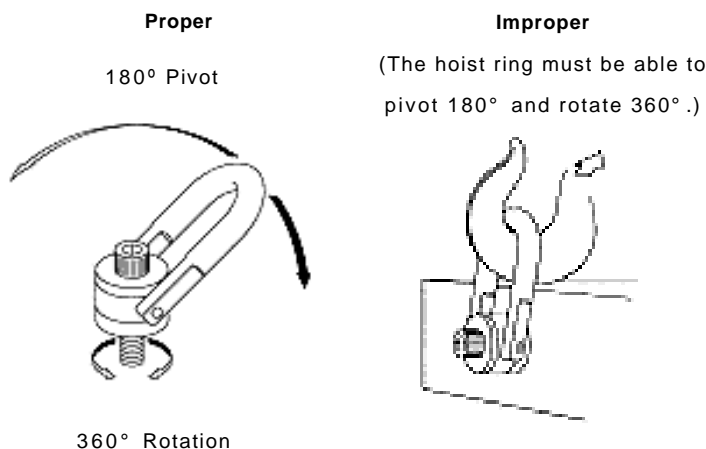
Figure 2-1. Use of Swivel Hoist Rings

Investigators destructively tested two new swivel hoist rings of the same model. They pulled one of the new rings vertically (with the ring perpendicular to the attachment plane), and it failed at 24,000 lbs. They pulled the second new ring horizontally (with the ring parallel to the attachment plane), and it failed at 20,000 lbs. The ring that was pulled vertically failed similarly to the in-service ring that failed due to shearing of the support pins. The swivel collar failed on the ring that was pulled horizontally. Investigators examined the rings that were tested under a microscope and did not find any manufacturing defects. Metallurgical experts examined the swivel hoist ring that failed in service and did not find any indication of fatigue failure. From the testing data, examination of the failed in-service ring, and observations of indentations on the cask, investigators concluded that the swivel hoist rings on the cask were not defective and that the rigging crew overstressed them by misusing them as tie-down points during transit of the cask. Figure 2-1 illustrates proper and improper use of swivel hoist rings.

Investigators determined that the direct cause of the event was a defective or failed part because the swivel hoist ring failed when it was subjected to excessive force while it was used as a tie-down fixture, a configuration not recommended by the manufacturer.

Investigators identified three contributing causes for this event. The first cause was personnel error. Under schedule pressures to transfer the cask, the rigging crew did not identify the use of the swivel hoist rings in the tie-down configuration as a misuse of the devices contrary to the manufacturer's recommendations. They should have delayed transfer of the cask until a proper tie-down fixture was available. The second cause was a design problem in that a tie-down fixture was not designed and fabricated for the cask. The cask designers knew that it would be transported on the truck and should have designed and fabricated a tie-down fixture for that use.

- Facility supervisors reviewed the proper use of swivel hoist rings with rigging crews and incorporated information on their improper use into site rigging, crane, and forklift training.
